ANNUAL REPORT FOR 2004

Big Warrior and Little Warrior Creek Mitigation Site
Wilkes County
WBS Element 34404.4.1
TIP No. R-2239 B

Prepared By:
Office of Natural Environment & Roadside Environmental Unit
North Carolina Department of Transportation
January 2005

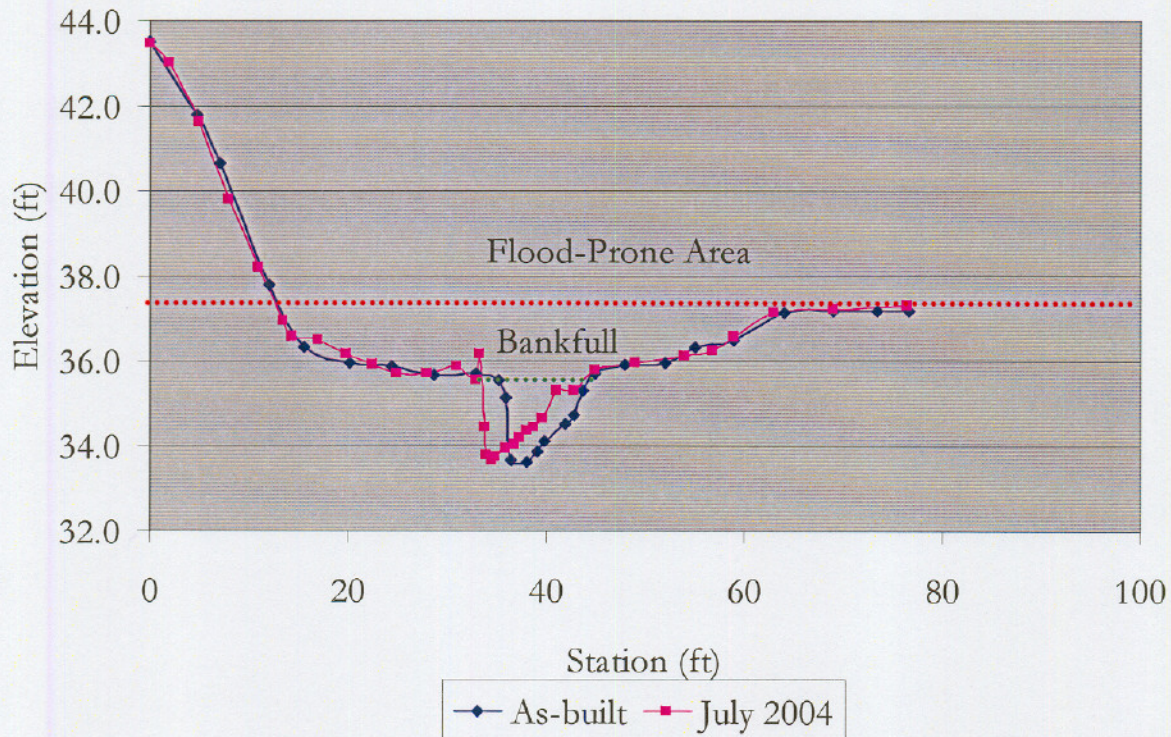
Cross Section #3 Big Warrior Creek

Cross-Section #3 (Riffle) Abbreviated Morphological Summary

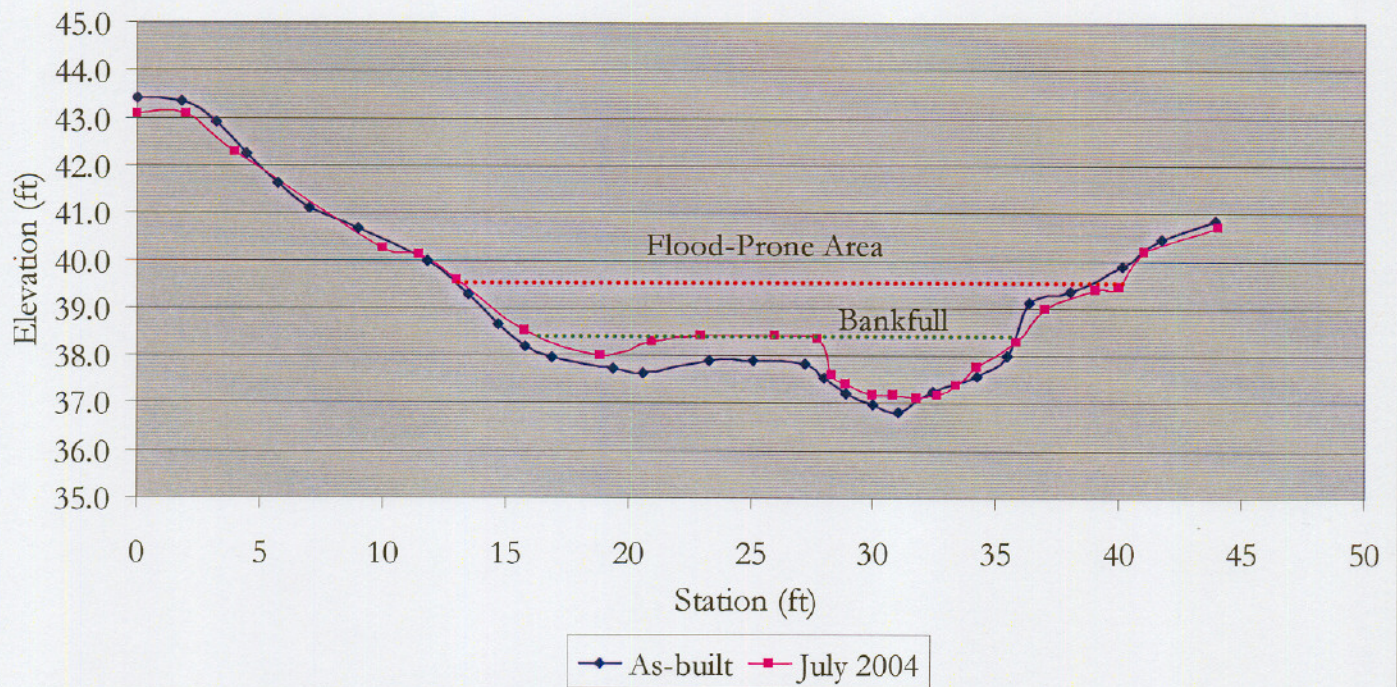
Cross Section #5 Big Warrior Creek

Cross-Section #5 (Riffle) Abbreviated Morphological Summary		
	As-built	2004
Bankfull Cross Sectional Area (ft ²)	20.3	7.8
Maximum Bankfull Depth (ft)	1.9	1.2
Bankfull Mean Depth (ft)	1	0.6
Width/Depth Ratio	22.3	22.3
Entrenchment Ratio	1.5	2.1
Bankfull Width (ft)	21.3	13.2
Width of Flood Prone Area	32	28

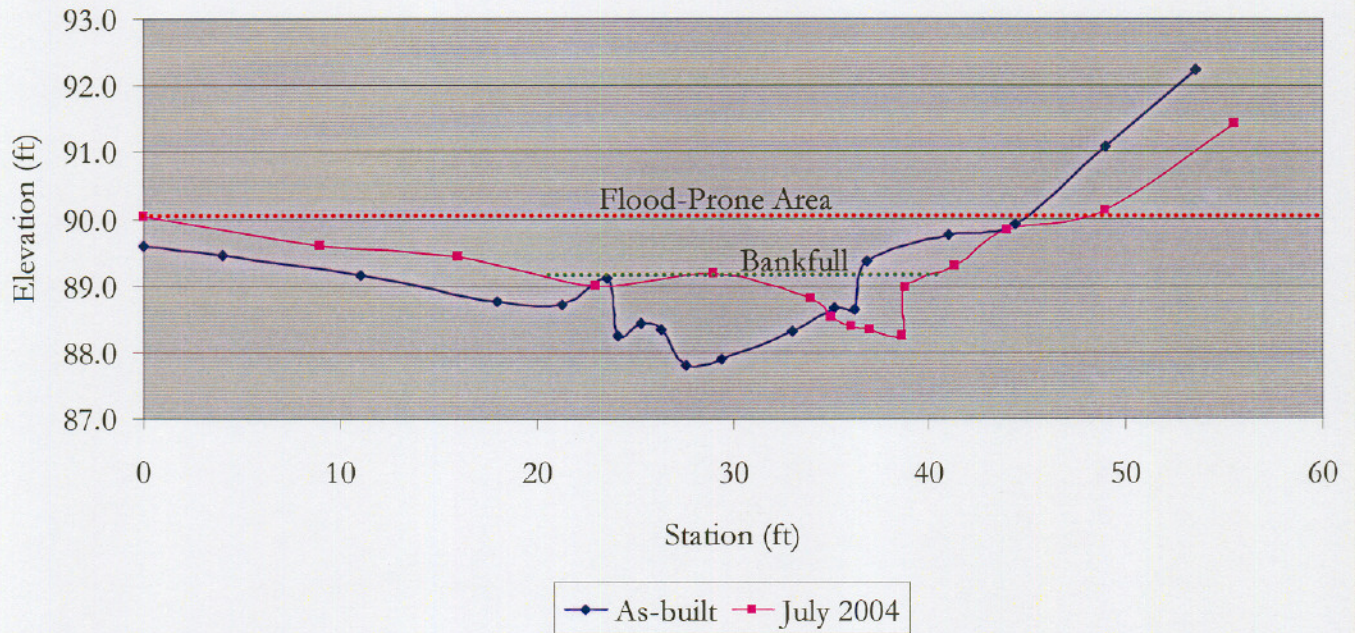
Cross Section #13 Big Warrior Creek

As-built	2004
Bankfull Cross Sectional Area (ft ²)	20.5	5.4
Maximum Bankfull Depth (ft)	1.6	0.9
Bankfull Mean Depth (ft)	1.6	0.3
Width/Depth Ratio	8.2	75.6
Entrenchment Ratio	3.4	2.4
Bankfull Width (ft)	13	20.2
Width of Flood Prone Area	45	49

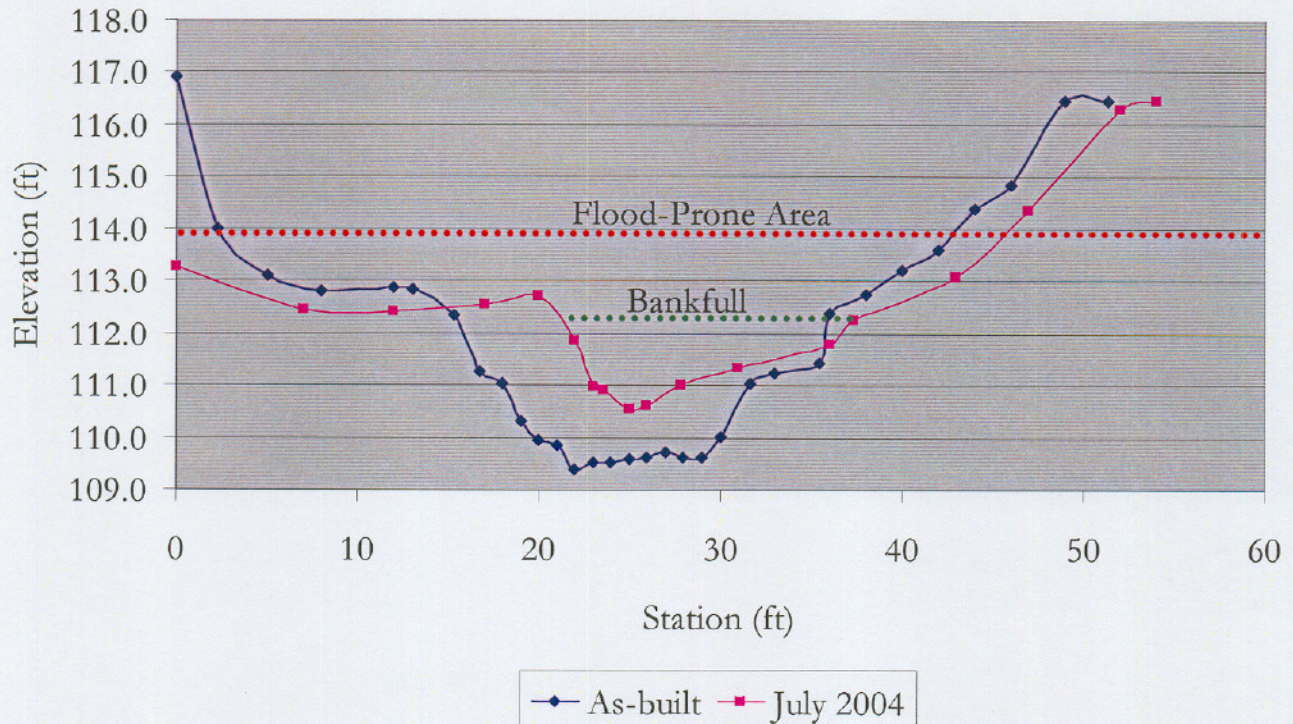
Cross Section #16 Big Warrior Creek

Cross-Section #16 (Riffle) Abbreviated Morphological Summary		
	As-built	2004
Bankfull Cross Sectional Area (ft ²)	40.7	15.3
Maximum Bankfull Depth (ft)	3	1.7
Bankfull Mean Depth (ft)	2.9	0.9
Width/Depth Ratio	72.6	17.3
Entrenchment Ratio	2.5	3.1
Bankfull Width (ft)	14	16.3
Width of Flood Prone Area	46	50

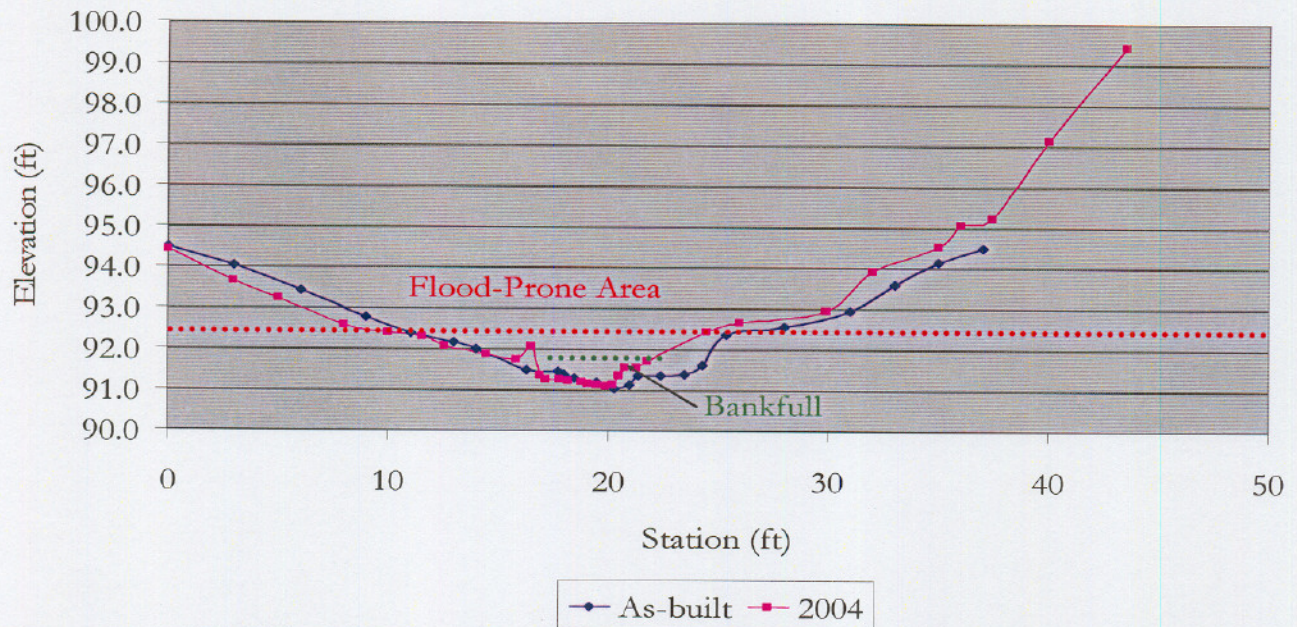
Cross Section #7 Little Warrior Creek

Cross-Section #7 (Riffle) Abbreviated Morphological Summary		
	As-built	2004
Bankfull Cross Sectional Area (ft ²)	10.6	2.2
Maximum Bankfull Depth (ft)	1.3	0.6
Bankfull Mean Depth (ft)	0.8	0.4
Width/Depth Ratio	18.3	12.5
Entrenchment Ratio	2.1	3
Bankfull Width (ft)	13.9	5.3
Width of Flood Prone Area	28	16

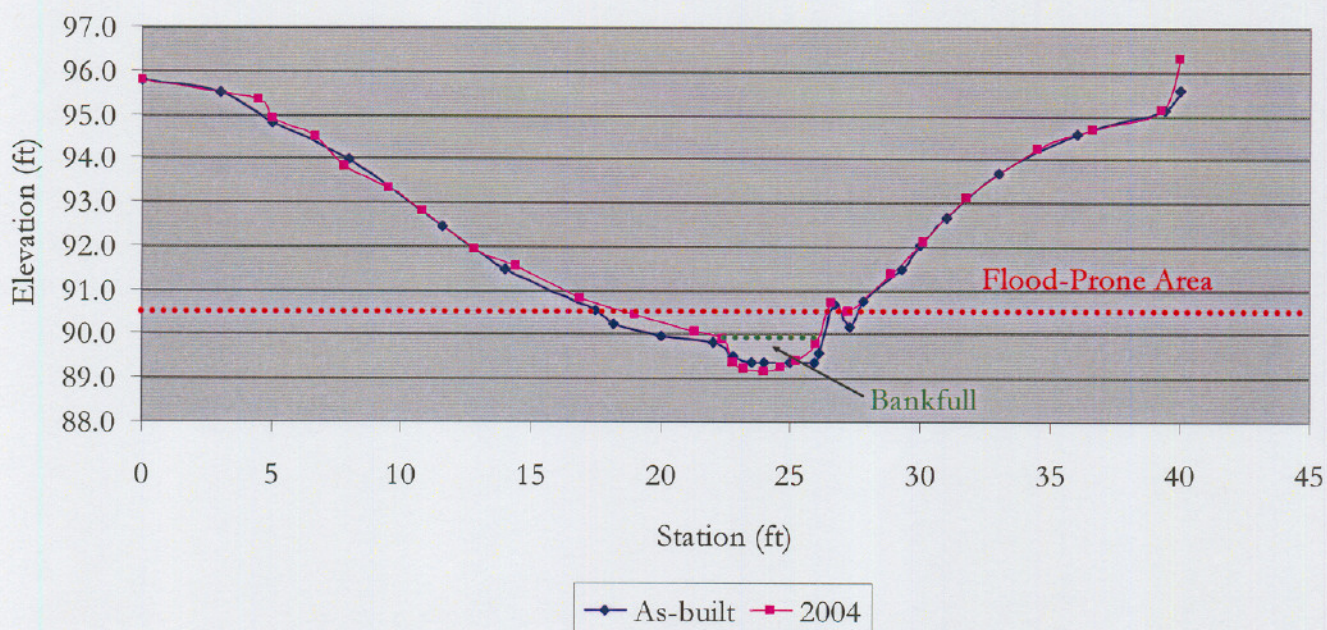
Cross Section #10 Little Warrior Creek

Cross-Section #10 (Riffle) Abbreviated Morphological Summary

As-built	2004
Bankfull Cross Sectional Area (ft ²)	7.2	1.8
Maximum Bankfull Depth (ft)	1.2	0.7
Bankfull Mean Depth (ft)	0.7	0.5
Width/Depth Ratio	14	7.3
Entrenchment Ratio	1.7	2.7
Bankfull Width (ft)	10	3.7
Width of Flood Prone Area	16	10

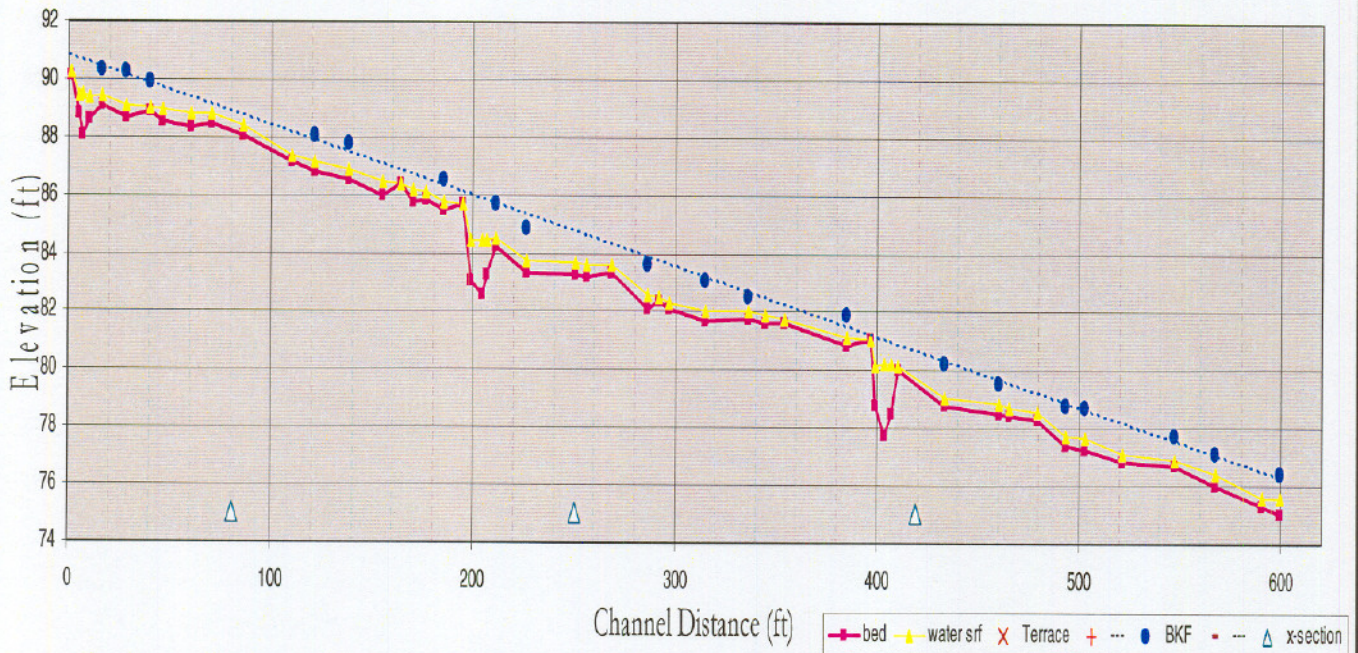
Big Warrior Creek - Feed Lot

- ◆ The structures in this segment of profile are also not functioning properly. The structure immediately downstream of the culvert under Andrew's Road has lost several of its rocks, including the header rock. Other structures in this segment were also noted as having water flowing around them or underneath the header rocks.

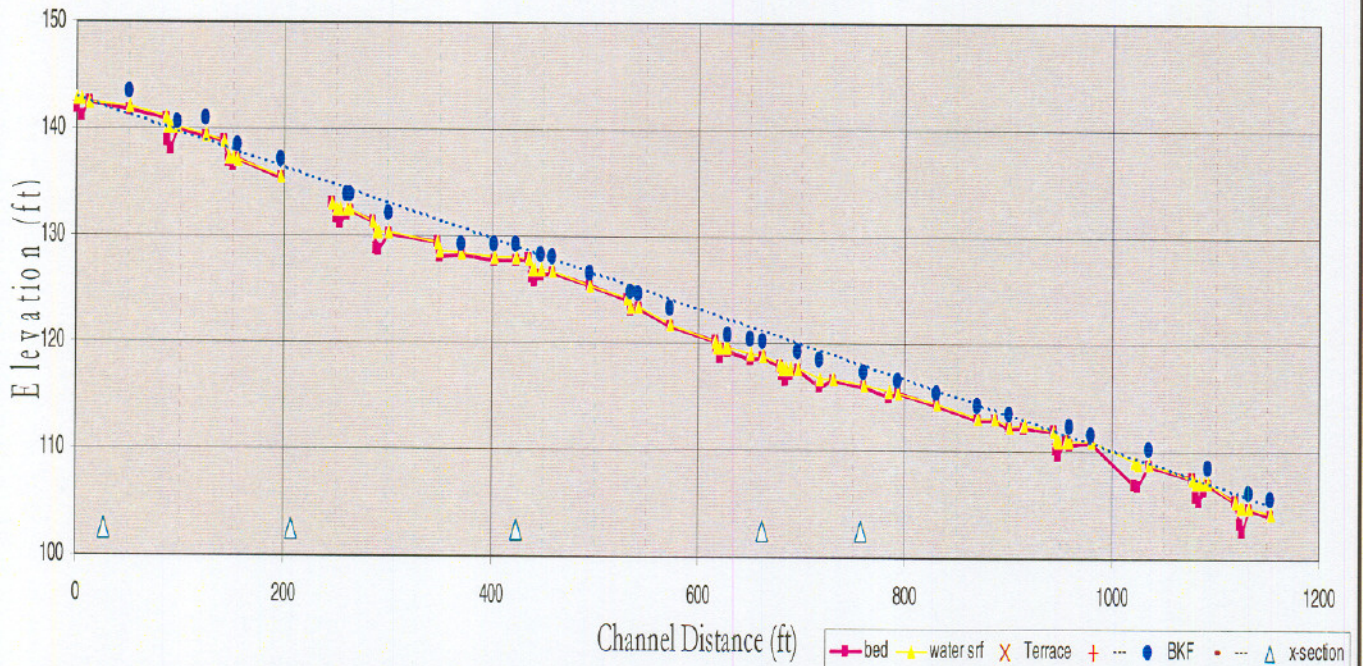
Big Warrior Creek - Upper Pasture

- ◆ The structures along this segment of profile are not functioning properly. A structure near the beginning of profile has become unstable. The header rock along with other rocks that make up the structure have become dislodged and are now scattered downstream. A large scour area has formed just downstream of this structure. This scour along the left streambank extends beyond the conservation easement. Other structures in this segment were noted as having water flowing around them or underneath the header rocks.
